Evaluation of Potential Aseismic Creep Along the Ouachita Frontal Fault Zone, Southeastern Oklahoma

NEHRP External Grant Award Number 03HQGR0030

Keith I. Kelson

William Lettis & Associates, Inc., 1777 Botelho Drive, Suite 262, Walnut Creek, CA 94596

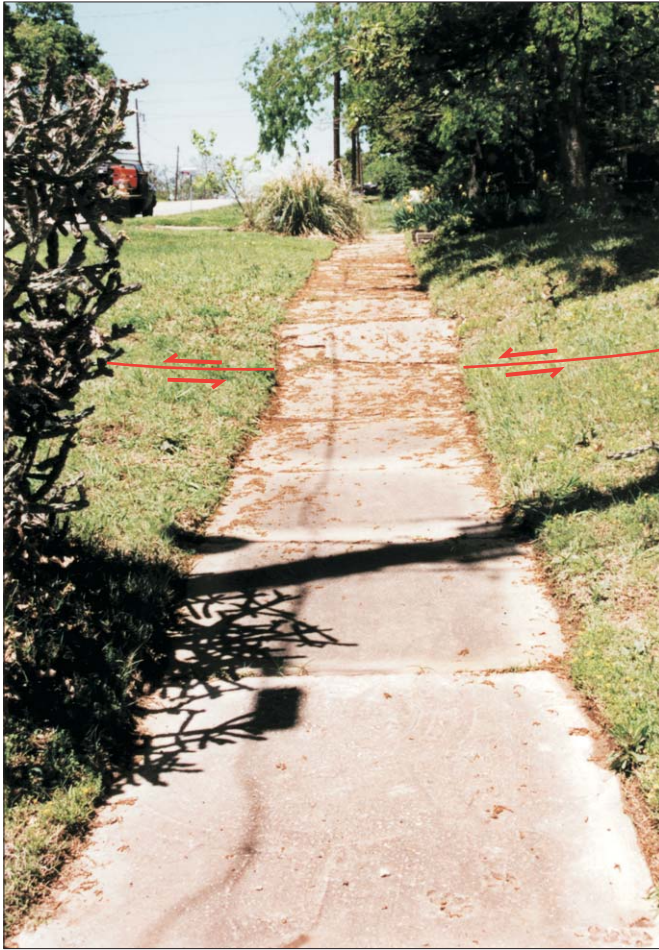
Figure 4. Photographs of sidewalk and curb deformation at corner of Court Street and Montana Avenue. A) Looking west northwest along sidewalk on Court Street, Showing left lateral offset and Down-to-the-west displacement. B) looking north-northeast at scarp in sidewalk and deformation in stone curb along Court Street.

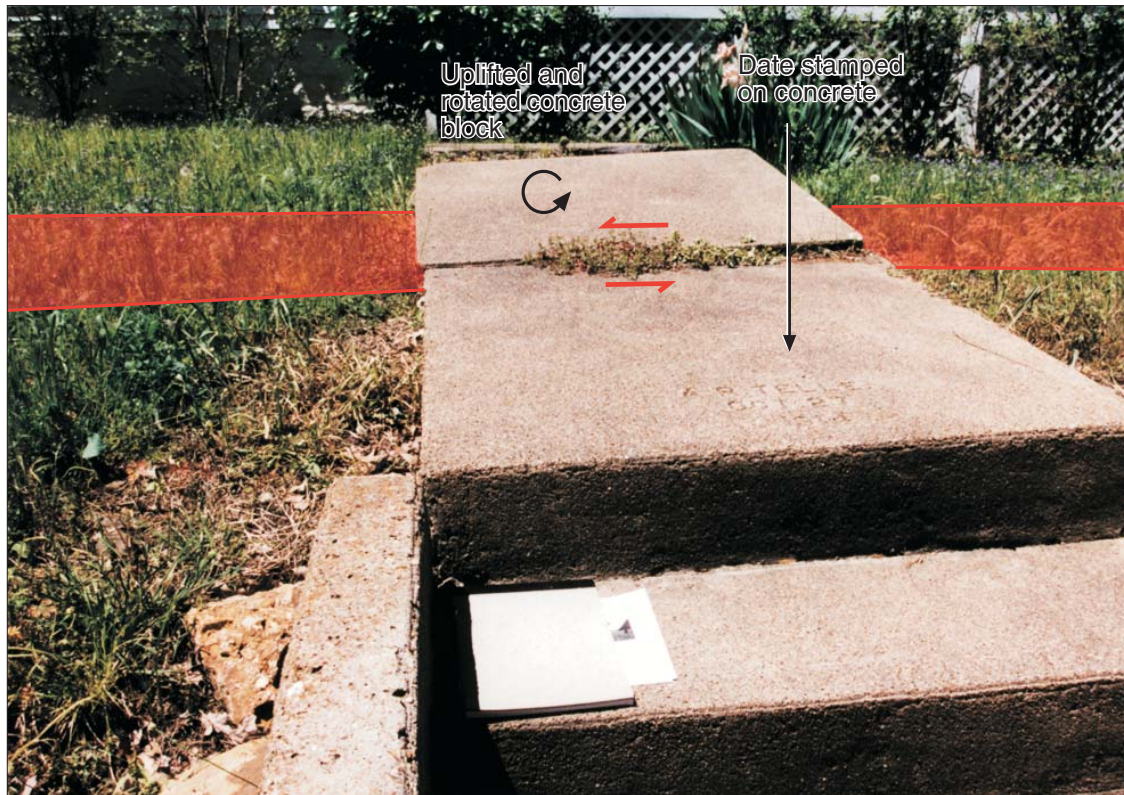
Figure 5. Photograph looking west-northwest along path orthogonal to Montana Avenue, showing left-lateral offset, uplift and rotation of concrete blocks. Concrete is stamped with date October 27, 1914. Measurement made on April 28, 1997, shows a total 14 cm of lateral offset across the entire path between wooden fence in background and steps in foreground.
